Property Inspection Report

3999 Chelsea Ln. Marietta, GA 30062

01/22/2015

Probe Home Inspections, LLC

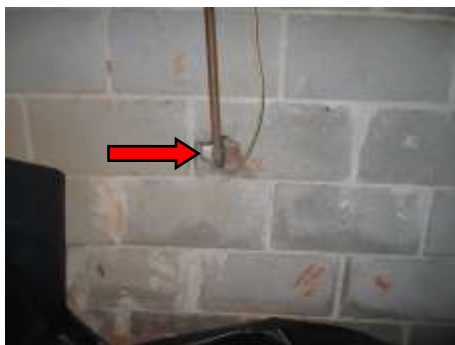
- **Repair:** All potential vermin entry points to the crawl space should be sealed to reduce risk of pest activity or damage.

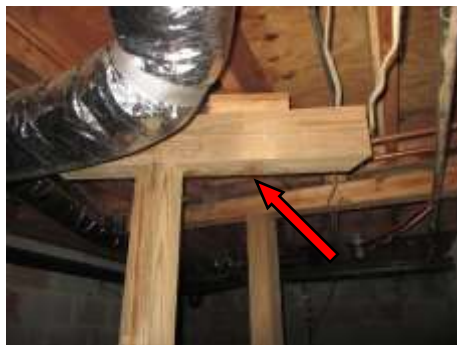
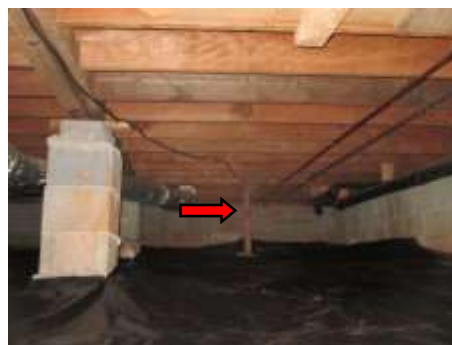
- **Monitor:** Liberties have been taken with good framing techniques as noted in the crawl space where vertical lumber has been installed to help support the floor. The supports are loose and have not been properly anchored to the joists. Recommend consulting with a framing contractor to determine the adequacy and durability of the framing installation (See Photos).

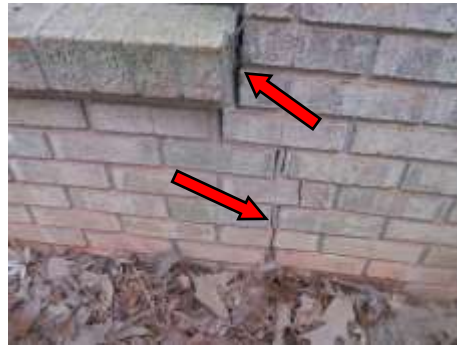
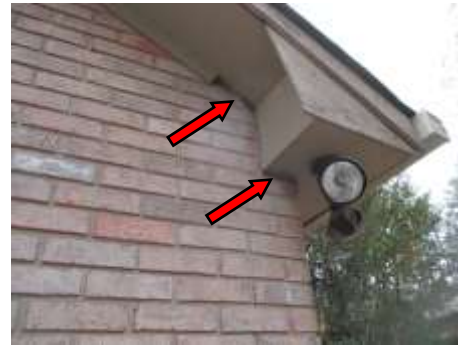
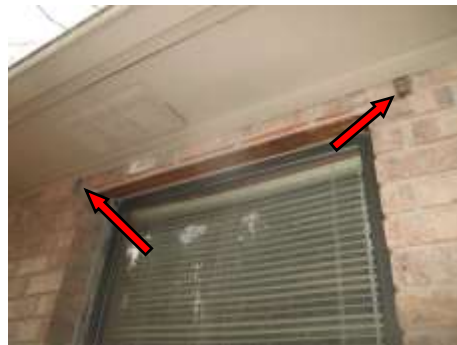
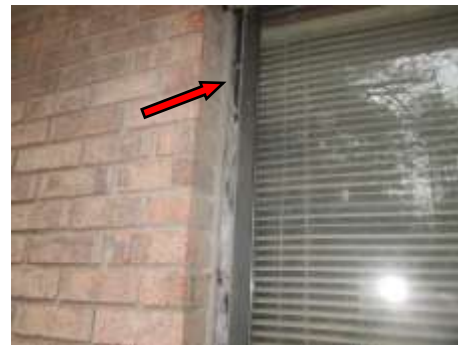
- **Repair, Monitor:** The left rear corner of the structure at the garage has settled somewhat resulting in brick separation from the framing and a crack below the right side of the window. Recommend repointing all gaps with mortar. Since additional movement could lead to need for repairs, this area should be monitored (See Photos).
- **Repair:** Sealant should be used in the gap between the garage window and the brick veneer (See Photo).

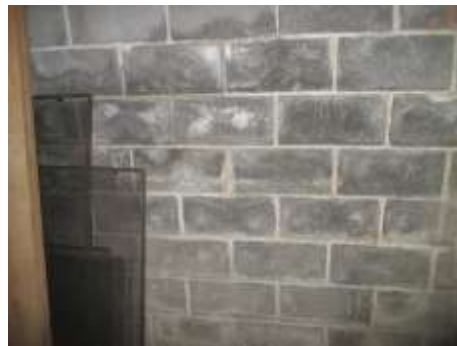
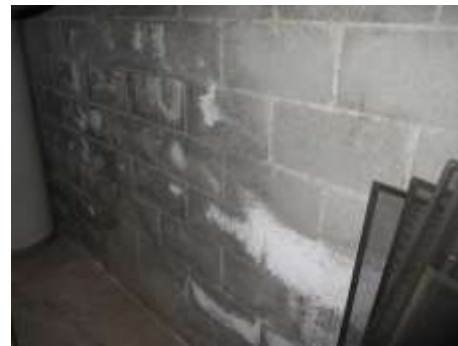
- **Monitor:** Efflorescence (white salt deposits) and moisture were observed in the front block foundation wall where the furnace is located. Active leaking was not observed at the time of inspection. Recommend monitoring for any visible signs of water. In the absence of an active water leak, repair should not be necessary (See Photos).

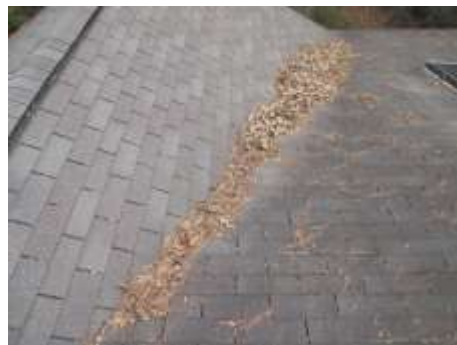
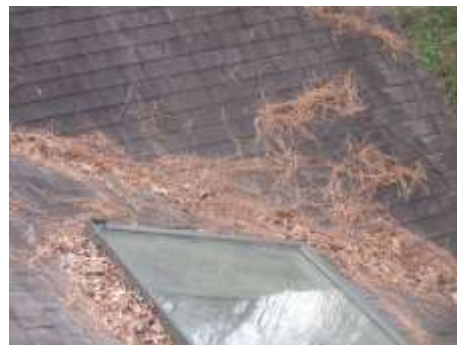
- **Monitor:** The roofing shingles lack flexibility (tear easily when gently bent) which is a sign of older material nearing the end of its life expectancy. While there is no evidence of moisture in the attic, periodic inspection of the shingles and the decking material in the attic is recommended to identify any leaks before significant water damage can occur.
- **Repair:** All debris should be removed from the roof in order to prevent the accumulation of moisture and further damage to the shingles (See Photos).

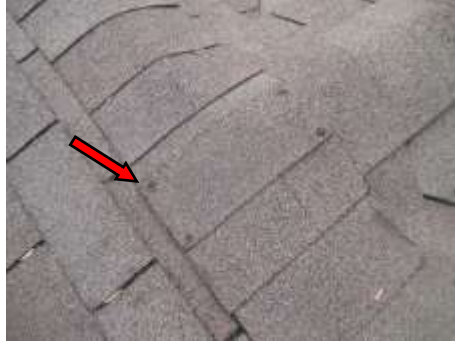
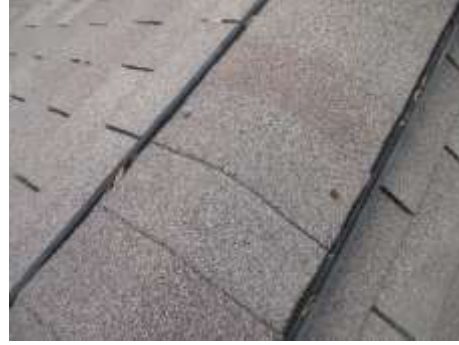
- **Repair:** Nail heads are exposed at some of the ridge vents. They should be sealed to reduce risk of leaks (See Photos).

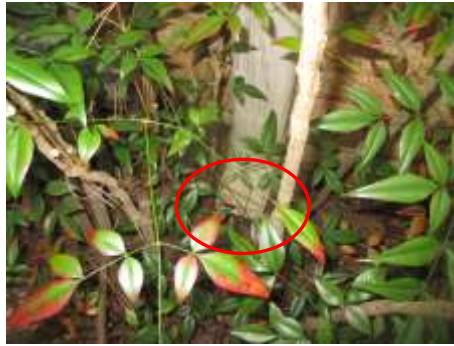
- **Repair:** The downspouts should discharge water at least five (5) feet from the house. Storm water should be encouraged to flow away from the building at the point of discharge. Recommend a downspout extension be installed at the front right downspout (See Photo).

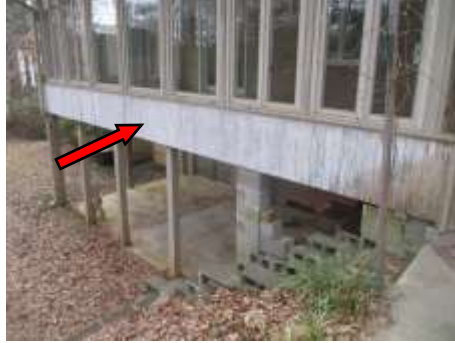
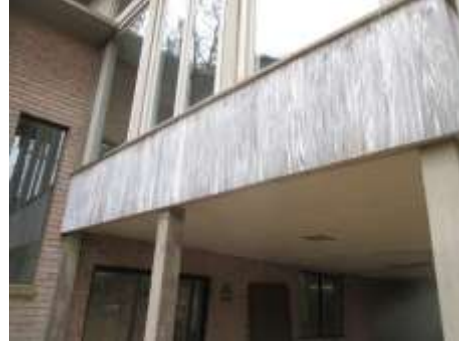
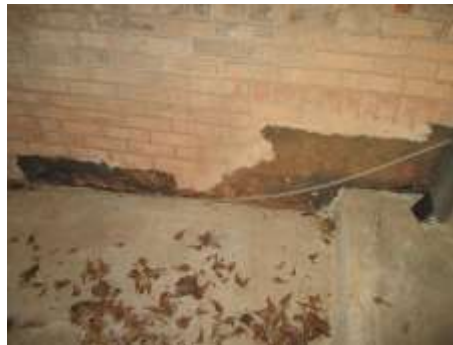
- **Repair:** The wood siding around the bottom of the sunroom should be painted or stained to protect the wood from further damage (See Photos).
- **Monitor:** A previous repair was noted at the back of the home to the right of the sliding glass door. This appears to have been patched due to possible water infiltration. This patch was likely to have been made prior to the sunroom addition. The inside of the home was dry at the time of inspection (See Photo).

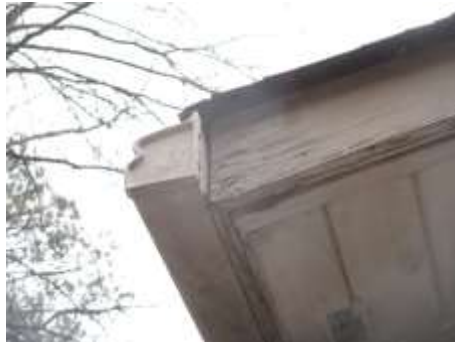
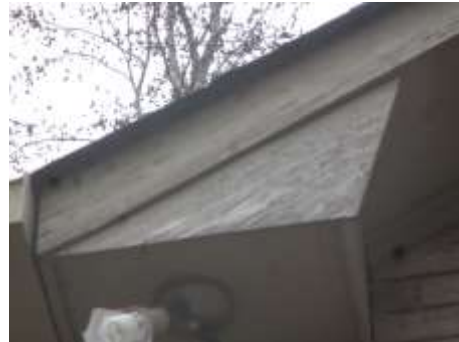
- **Repair:** Localized deterioration was observed in the fascia (the wooden board to which the gutter is typically fastened). Repair should be undertaken to prevent further damage (See Photos).

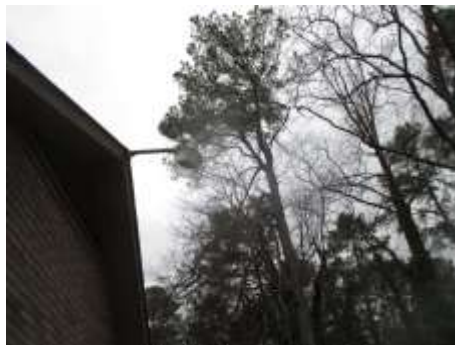
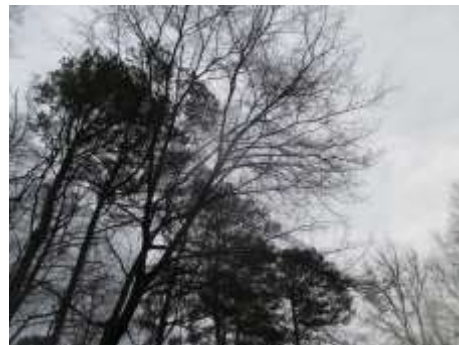
- **Improve:** The proximity of the trees in the backyard pose a threat to the home. Recommend removal of selected trees to prevent potential damage to the home (See Photos).

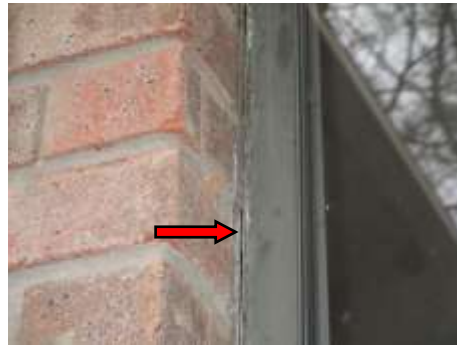
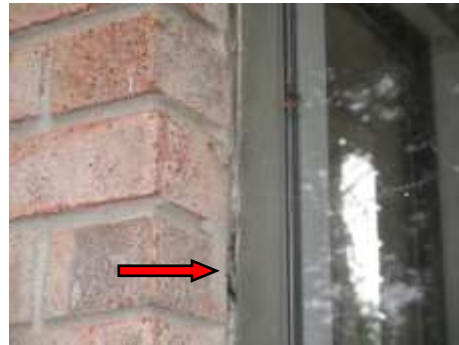
- **Repair:** Some of the windows at the front of the home require caulking to prevent the possibility of moisture intrusion (See Photos).

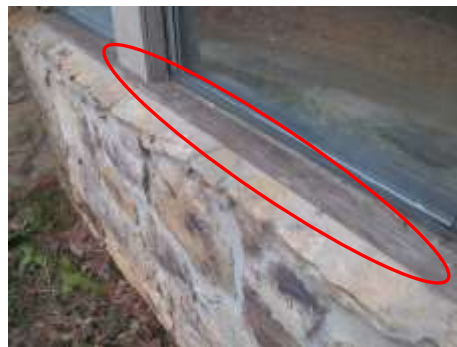
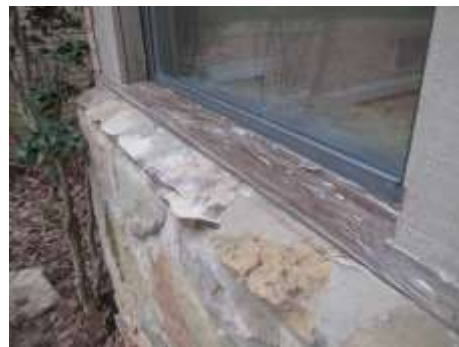
- **Repair:** Localized evidence of deterioration was visible at the front window sills. Repairs should be undertaken when painting (See Photos).

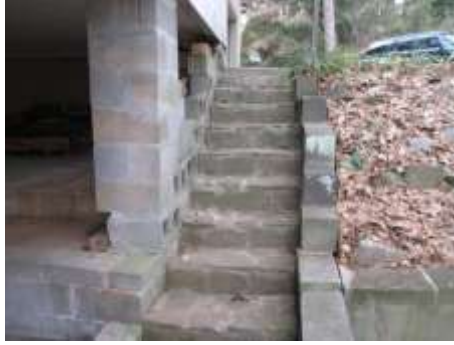
- **Improve, Safety Issue:** Recommend a handrail for the stone steps at the rear of the home (See Photo).

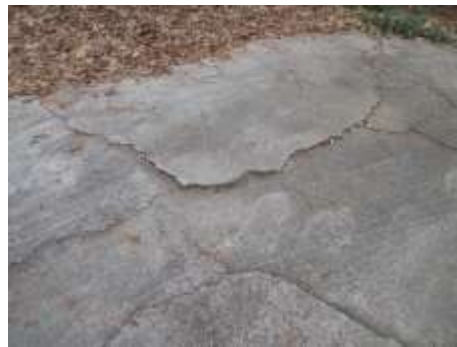
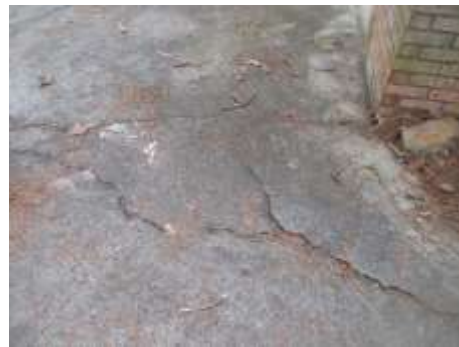
- **Monitor:** The soil below the driveway has settled and/or heaved in certain areas. Persisting movement may result in the need for resurfacing (See Photos).

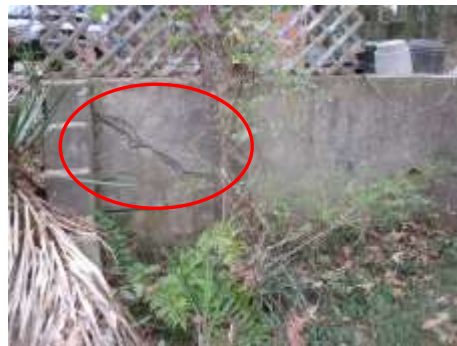
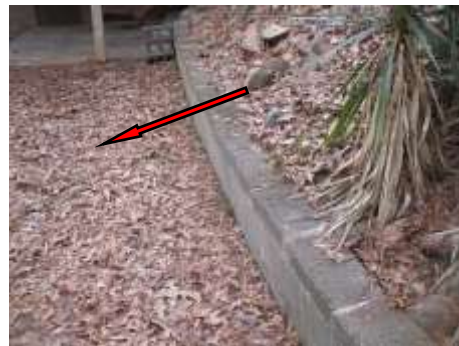
- **Monitor:** The concrete retaining wall in the back yard below the driveway shows evidence of cracking and decay. This condition should be monitored. It is impossible to determine the rate of movement during a one time visit to the house (See Photo).
- **Monitor:** The block retaining wall at the backyard shows signs of movement. Recommend this be monitored for further movement at which time replacement may become necessary (See Photo).

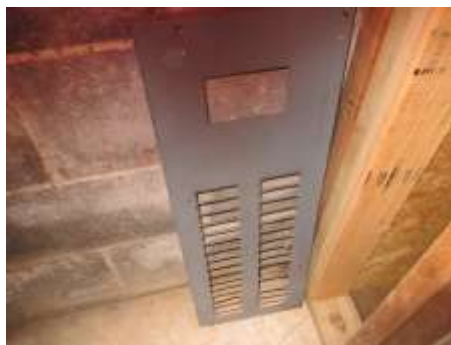
- **Improve, Safety Issue:** Blunt screws should be used to secure the service panel to the wall. Additionally, only two screws are holding the panel in place. Recommend adding the requisite number of screws.
- **Repair:** The interior cover plate for the main panel is on the floor and needs to be installed (See Photo).

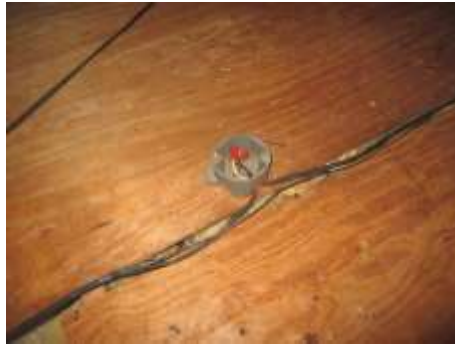
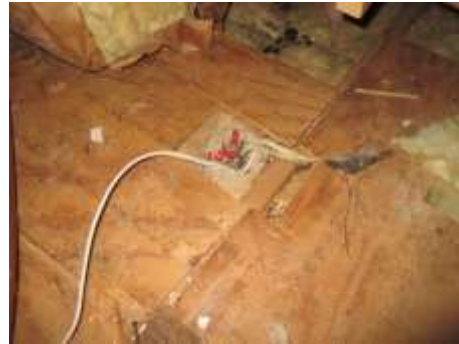
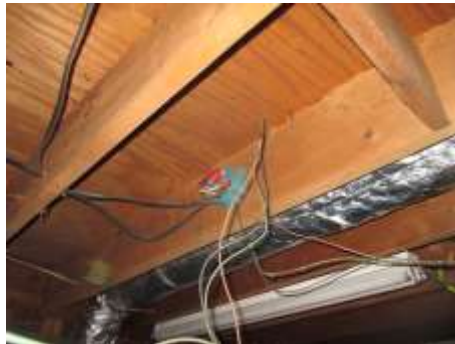
- **Repair:** All open junction boxes as noted in the attic and basement should be fitted with cover plates in order to protect the wiring and reduce the risk of potential fires that may be caused by poor connections (See Photos).

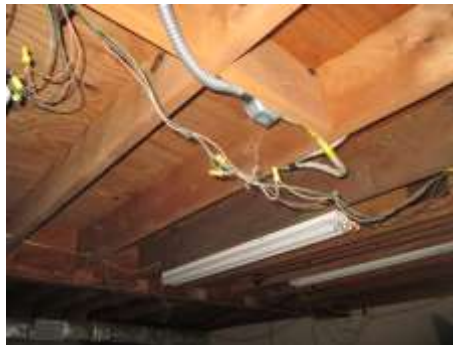
- **Repair:** Loose wiring is hanging from the basement ceiling which should be installed inside conduit and junction boxes (See Photos).

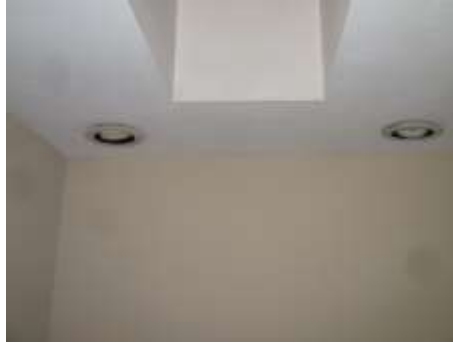
- **Repair:** The track lighting in the kitchen and the track lighting at the right side of the family room were inoperable. The lighting in these areas needs to be evaluated and repaired.
- **Improve:** The covers for the pot lights above the master vanity need to be flush mounted to the ceiling (See Photo).

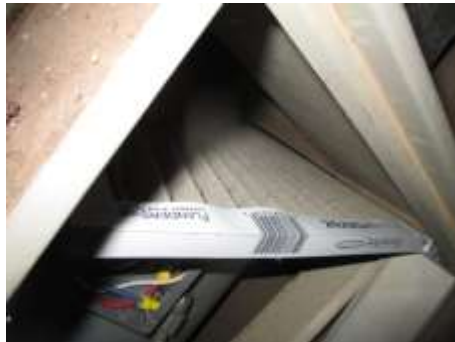
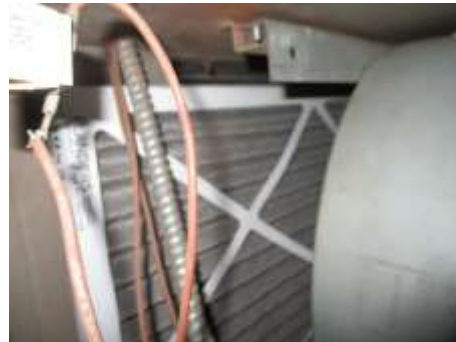
- **Repair, Safety Issue:** The heating system requires service and cleaning by a qualified HVAC service company due to rust in the burner chamber area, which can indicate corrosion and damage to the heat exchanger. The heat exchanger should be checked for cracks, which can allow carbon monoxide poisoning to infiltrate the supply air. The air filters should be replaced. At the time of inspection the furnace was short cycling. Repair is necessary.
- **Concern:** Given the age of the furnace, it may be near the end of its useful life. You should reserve funds to be ready to purchase a new furnace.
- **Repair:** The dirty furnace air filters should be replaced (See Photos).

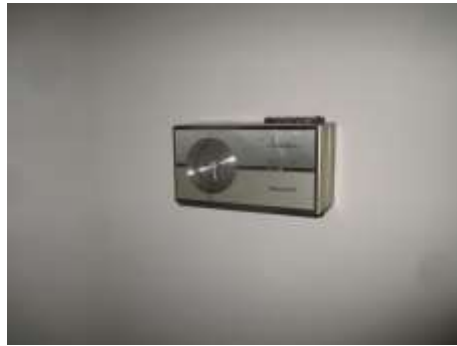
- **Monitor:** The thermostat is old and may be temperamental. Replacement is a minor job (See Photo).

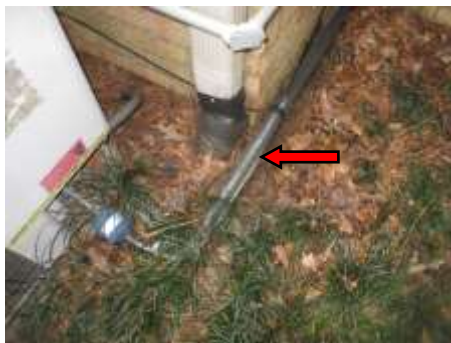
- **Concern:** As is not uncommon for homes of this age and location, the air conditioning system is relatively old. It will require a higher level of maintenance, and may be more prone to major component breakdown. Predicting the frequency or time frame for repairs on any mechanical device is virtually impossible. If the compressor fails, or if breakdowns become chronic, replacing the entire system may be more cost-effective than continuing to undertake repairs.
- **Repair:** Damaged and or missing insulation on refrigerant lines should be repaired. These outside lines should be insulated all the way to the compressor unit to prevent loss of temperature in the lines (See Photo).

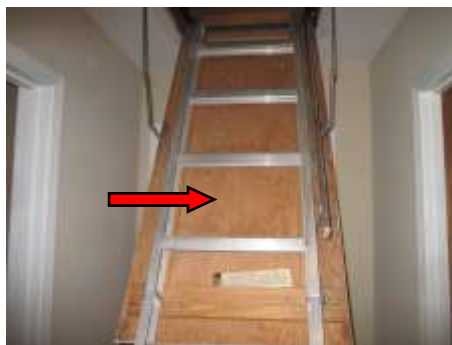
- **Improve:** The attic insulation should be improved to R30, which is the present day standard. Any missing attic insulation such as noted throughout the attic should be added for proper protection against loss of conditioned air into the attic. The pull-down attic access door should be insulated with foam board and weather stripped to limit unconditioned air infiltration into finished areas (See Photo).

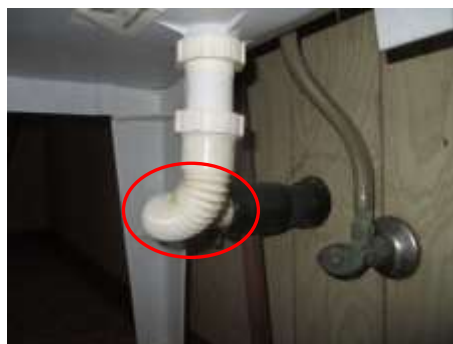
- **Improve:** There is a flexible drain pipe located under the laundry tub which is prone to clogging. Recommend replacing with rigid smooth walled pipe per proper plumbing technique (See Photo).

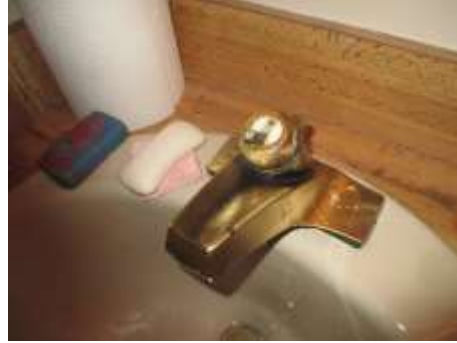
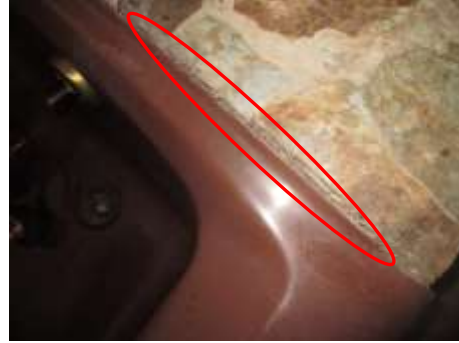
- **Repair:** The faucet is broken in the basement bathroom. Repair or replacement is necessary (See Photo).
- **Repair:** The toilet is loose as noted in the master water closet. Have the toilet properly bolted to the floor.
- **Repair:** Cracked, deteriorated and/or missing bathtub enclosure grout in the master bath should be replaced (See Photo).
- **Repair:** The drain plugs for the master and spare bathtubs are damaged and should be replaced.
- **Repair:** The laundry tub should be properly secured to the floor to prevent loosening of plumbing connections.

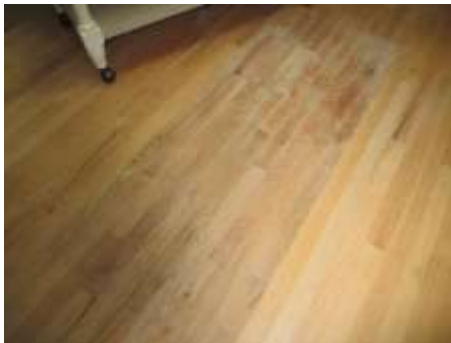
- **Improve:** The floor underneath the center island in the kitchen is not finished. Improvement is optional (See Photo).

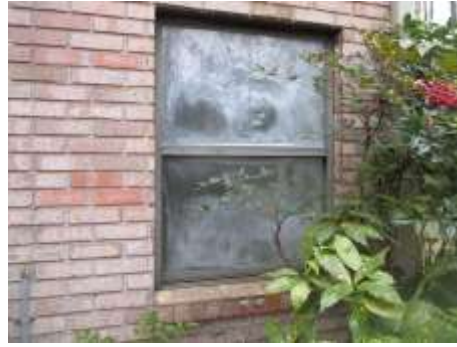
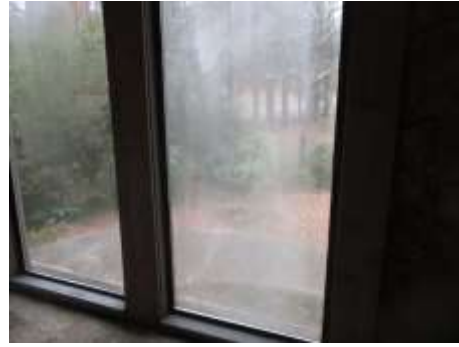
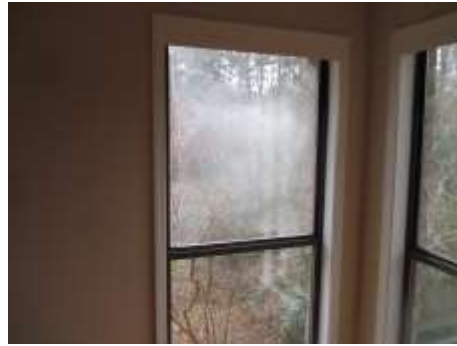
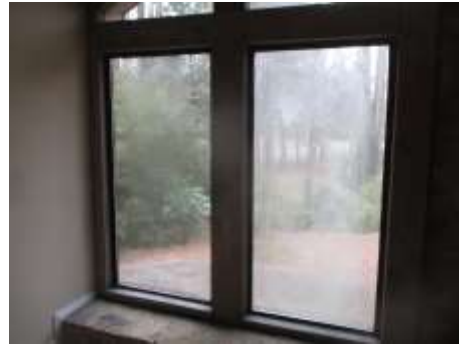
- **Monitor:** The windows are old and in mild disrepair. This is a common condition that does not necessitate immediate major repair. The most important factor is that the window exteriors are well-maintained to avoid rot or water infiltration.
- **Repair:** The window in the back basement bedroom has a broken spring which means that the window will not stay open without the means of artificial support. Repair may be desirable.
- **Improve:** Several of the windows have lost their seals. This has resulted in condensation developing between the panes of glass. This “fogging” of the glass is primarily a cosmetic concern, but may need to be replaced because it has lost its insulating value (See Photos).

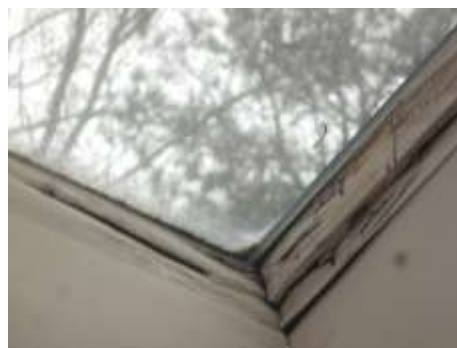
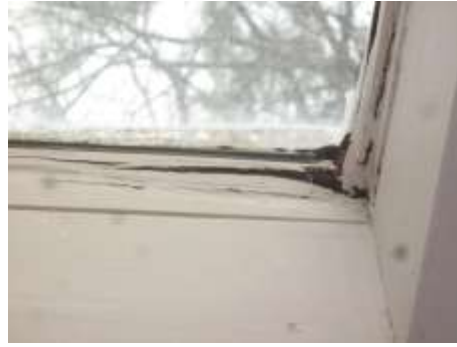
- **Repair:** The interior finishes below the sunroom skylights show evidence of water damage. The infrared camera suggests moisture is present. The skylights should be repaired as necessary (See Photos).

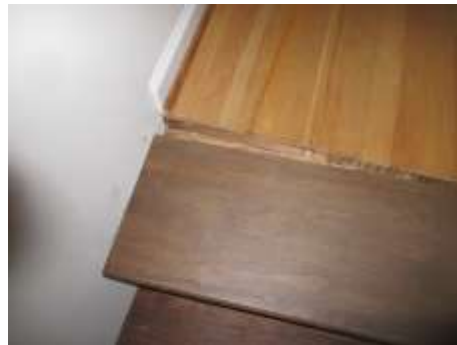
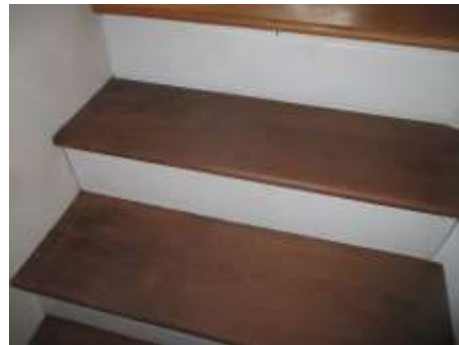
- **Repair:** The top step of the basement stairway needs to be fastened to the floor (See Photo).
- **Repair:** Loose treads on the basement stairway should be securely installed to the frame (See Photo).
