Property Inspection Report

3999 Chelsea Ln. Marietta, GA 30062

01/22/2015

Probe Home Inspections, LLC

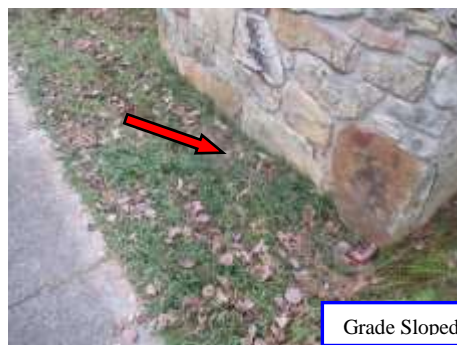
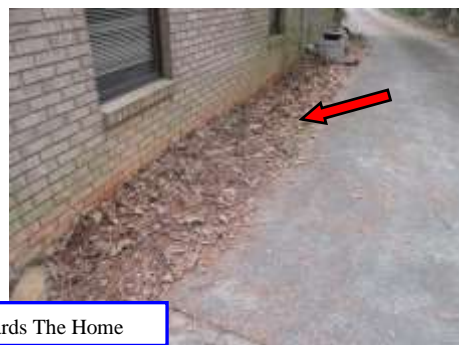
- **Improve:** The grading should be improved at the front and left sides of the home to promote the flow of storm water away from the house. This can often be accomplished by the addition or re-grading of top soil. The ground should slope away from the house at a rate of one inch per foot for at least the first ten feet. At least eight (8) inches of clearance should be maintained between soil level and the bottom of exterior wall siding (See Photos).

Grade Sloped Towards The Home

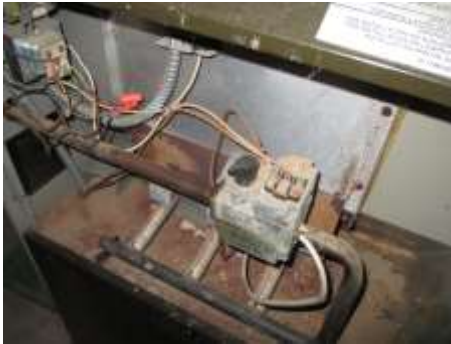
- **Repair, Safety Issue:** The heating system requires service and cleaning by a qualified HVAC service company due to rust in the burner chamber area, which can indicate corrosion and damage to the heat exchanger. The heat exchanger should be checked for cracks, which can allow carbon monoxide poisoning to infiltrate the supply air. The air filters should be replaced. At the time of inspection the furnace was short cycling. Repair is necessary.

The furnace appears to be approximately 34 years old based on the serial number. The typical life for such a unit is 20-25 years based upon proper maintenance scheduling. The furnace did not respond to normal operating controls at the time of inspection.

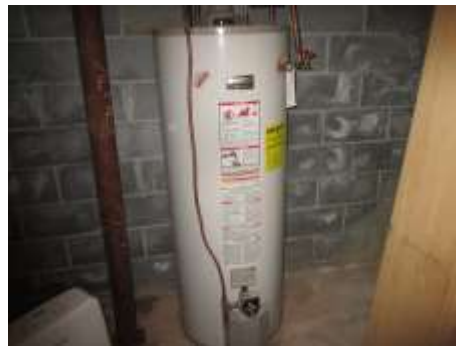
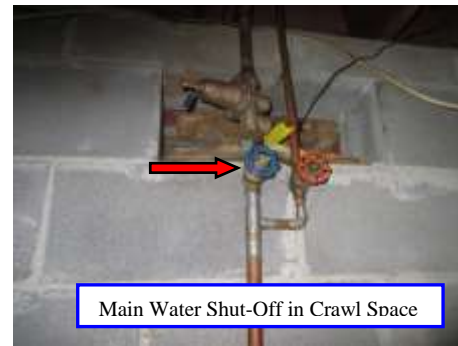
The water pressure could not be checked due to a stripped fitting at the water heater. Overall, the plumbing system is in generally good condition with only minor repairs or improvements recommended.

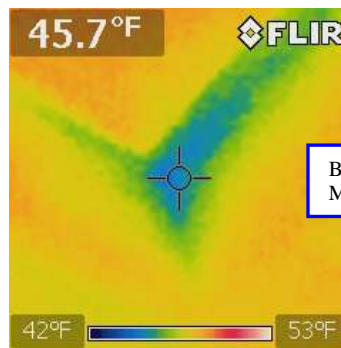
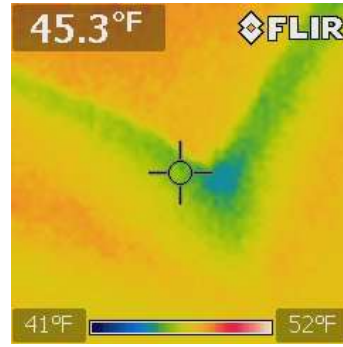
- **Repair:** The interior finishes below the sunroom skylights show evidence of water damage. The infrared camera suggests moisture is present. The skylights should be repaired as necessary (See Photos).

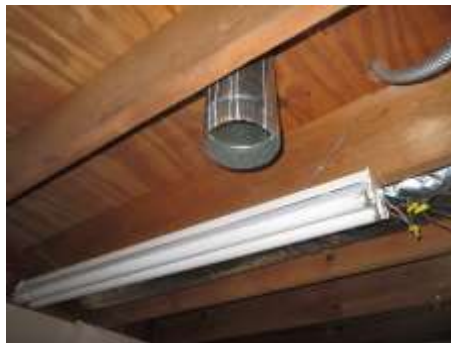
- **Repair:** The cooktop under cabinet exhaust fan should discharge to the building exterior rather than into the basement (See Photo).
